# Microcontroller Technical Information

32-Bit Microcontroller V850E/ME2  Usage Restrictions	Document No.	ZBG-CC-07-0022	1/1
	Date issued	October 1, 2007	
	Issued by	2nd Product Solution Group Multipurpose Microcomputer Systems Division Microcomputer Operations Unit NEC Electronics Corporation	
Related documents V850E/ME2 Hardware User's Manual: U16031EJ5V0UD00 (5th edition) V850E1 Architecture User's Manual: U14559EJ3V0UM00 (3rd edition)	Notification classification	√	Usage restriction
			Upgrade
			Document modification
			Other notification

### 32-Bit Microcontroller V850E/ME2 - Usage Restrictions

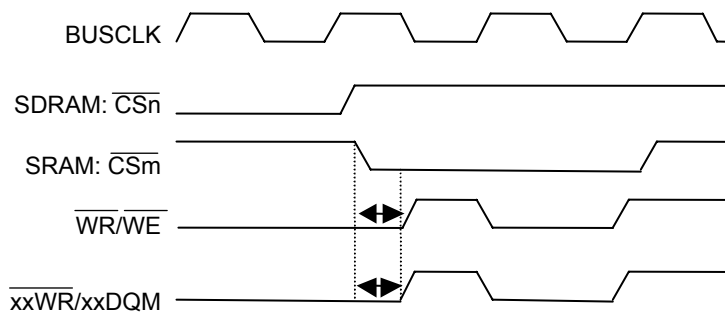
When an access to the SRAM interface device occurs immediately after an access to the SDRAM occurs, the rise (inactive timing) of the xxDQM (xxWR) signal or WE (WR) signal overlaps the SRAM interface device cycle, which may cause erroneous write (see the figure below).

Erroneous write may occur because the  $\overline{CSn}$  signal of the SDRAM falls before the  $\overline{xxWR/xxDQM}$  and  $\overline{WR/WE}$  signals rise.

- Use the IOWR signal, instead of the xxWR or WR signal, to access the SRAM interface device. In addition, configure a circuit so that the xxBE and IOWR signals are logically ORed externally if byte control is required.

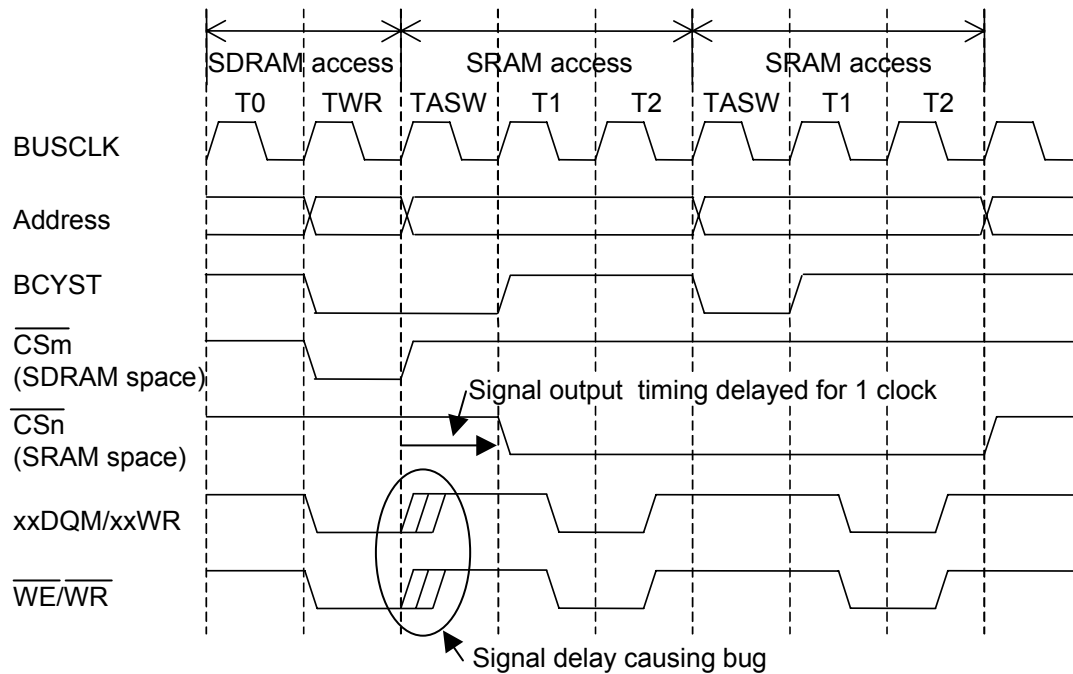
1. CSCDn = 1 (When a CS signal in SRAM cycle is delayed for 1 clock)

- SRAM access immediately after SDRAM access

(SRAM access is performed twice in succession immediately after SDRAM access)

SRAM settings: Address setup waits = 1, data waits = 0, CSCDn = 1

The following function has been added to bits 0, 4, 6, and 7 of the PFCCS register in products of rank E or later.

Bit position	Bit name	Function
0, 4, 6, 7	CSDCn	When this bit is set (1), the timing at which the corresponding chip select signal (CSn) falls is delayed by one clock. The output timing of signals other than CSn is not affected.

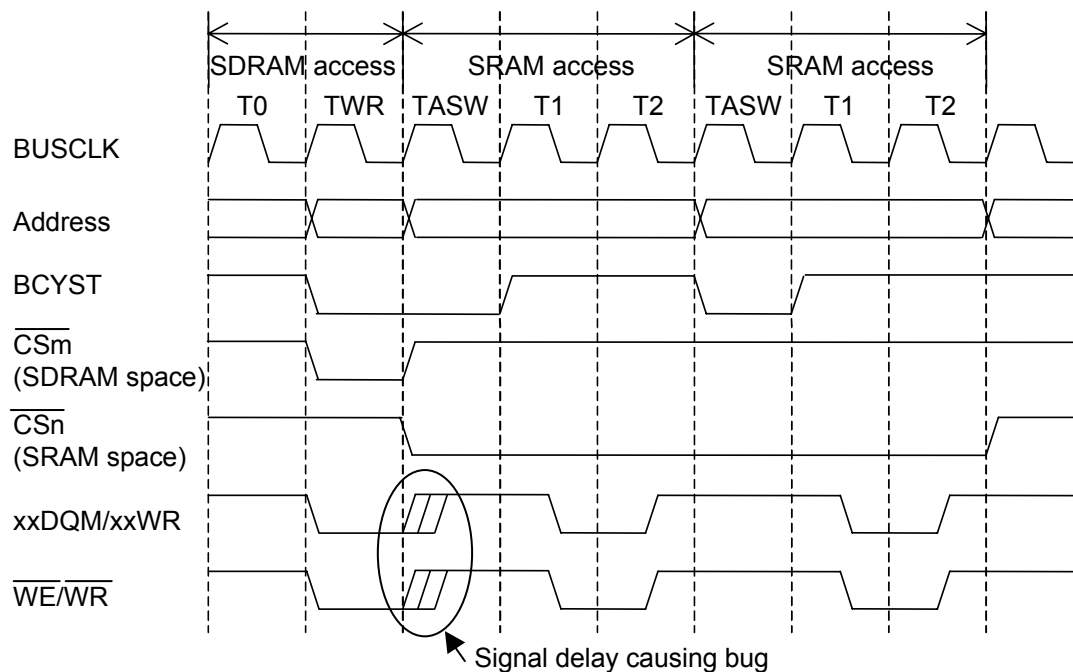
2. CSCDn = 0 (When no additional function is used)

**Remark** These are the timing diagram when no T0 state is inserted (this bug does not occur when a T0 state is inserted). See the user's manual for the detailed timing at which a T0 state is inserted.

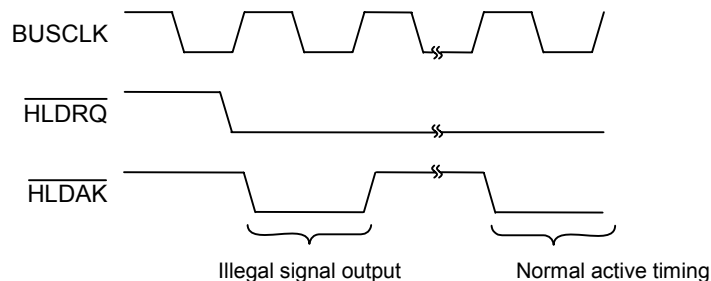
When one of the following operations and an active level input (fall) to the HLDRQ pin conflict, the HLDAC signal may become active for 1 BUSCLK illegally, then inactive, and active again after several BUSCLKs have elapsed (the second active operation is the normal HLDAC signal operation) (see the figure below).

Insert an external circuit to avoid <1> and <2> above.

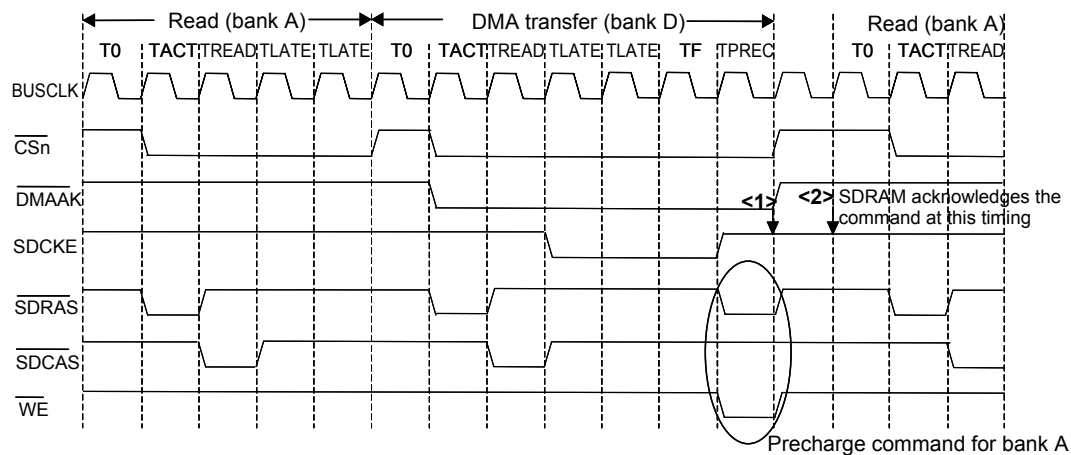
If a bank change occurs in the SDRAM when a read or write operation to the SDRAM and a DMA flyby transfer to the SDRAM are performed successively, a precharge command is generated at an illegal timing. Consequently, the subsequent SDRAM access may be illegal. In addition, if the latency with respect to the SDRAM is 3 or if the data size of the DMA transfer is set to a value larger than the bus width of the SDRAM, the SDRAM access command after the flyby transfer may be generated at an illegal timing, which may cause the subsequent SDRAM access to be illegal, regardless of bank change occurrence.

The V850E/ME2 controls waits when performing flyby DMA transfer to the SDRAM by inactivating the SDCKE signal (L level). When the SDRAM has accessed a bank (hereafter referred to as A) and this is followed by a DMA transfer to another bank (hereafter referred to as D), the V850E/ME2 activates the SDCKE signal (H level) and subsequently issues a precharge command (<1> in the figure below). However, the SDRAM can acknowledge commands only at the fall of the clock immediately after the H level of the SDCKE signal is detected (<2> in the figure below). Consequently, the precharge command output from the V850E/ME2 is not acknowledged, and the SDRAM access to bank A performed after the DMA transfer becomes illegal.

Use 2-cycle transfer instead of flyby transfer when performing DMA transfer from the SDRAM to external I/O.

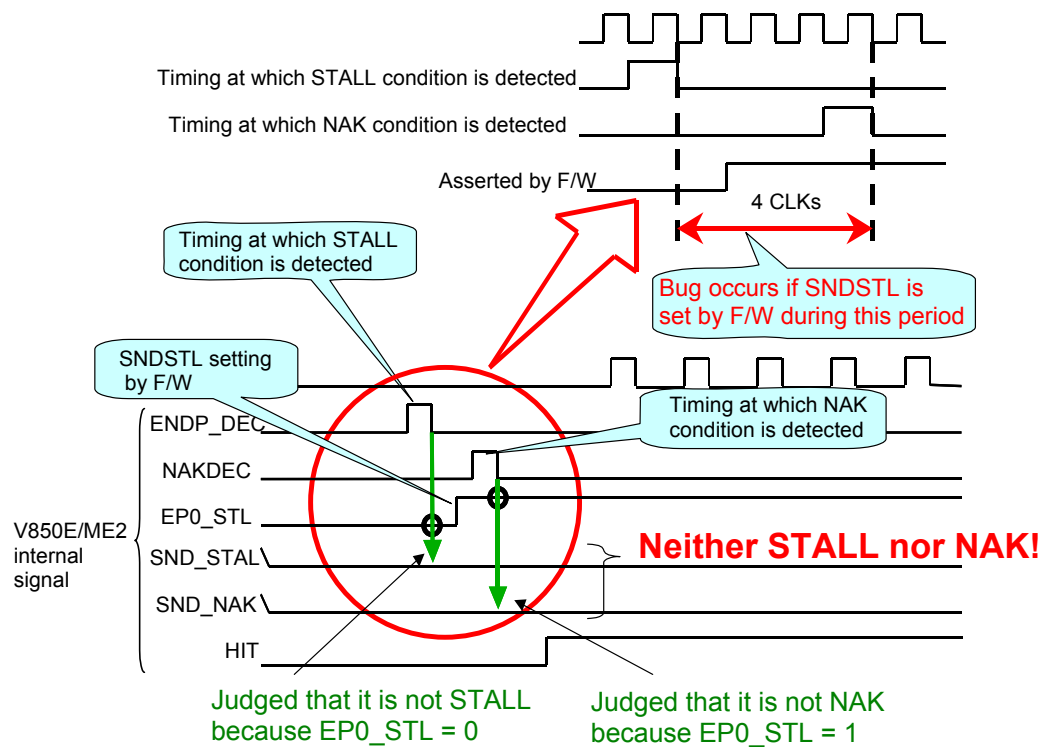
- (1) When the SNDSTL bit of the UF0SDS register is set in a specific period (4 USB clocks) during an IN transfer token phase for EP0, the data phase continues to transmit "00H" and cannot be completed normally (see the figure below for the detailed timing).
- (2) When the SNDSTL bit of the UF0SDS register is set in a specific period (4 USB clocks) during an OUT transfer token phase for EP0, the device returns ACK to the host in the data phase even if the buffer is in the NAK status.

When using the USB function of the V850E/ME2, there is a 4-USB-clock difference between the timing at which the STALL acknowledgment ready status is detected in the device and when the next NAK response is detected. If the SNDSTL bit of the UF0SDS register is set by software during this 4-USB-clock period, neither STALL nor NAK is recognized, which causes this bug.

Design the host driver so that a device request that is not recognized by the function driver is not output.
